Troubleshooting  
Loose Printhead Assembly

Troubleshooting  
**Z-Sensor Error**

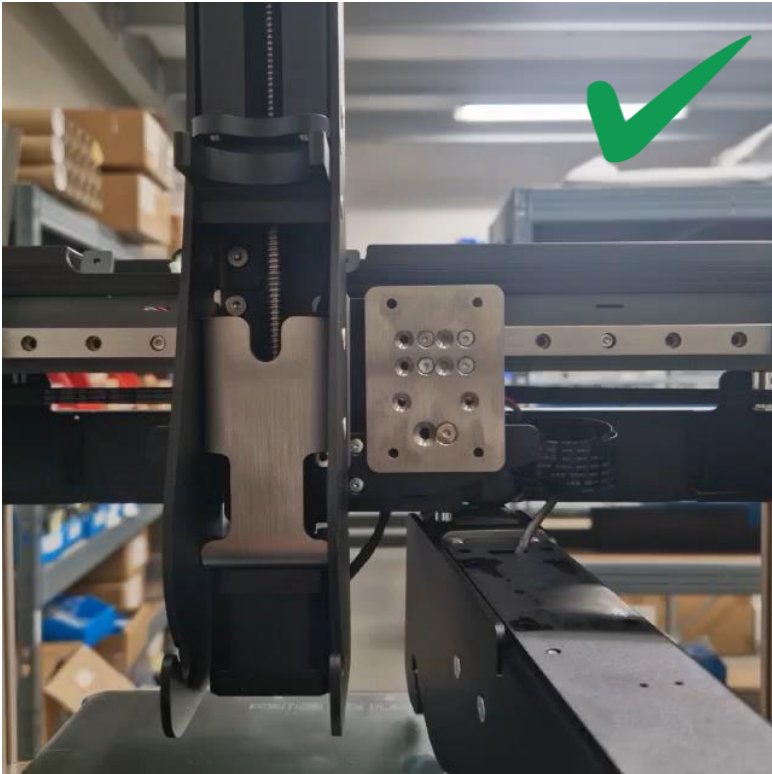
**RIGHT**

Interface plates  
should be parallel

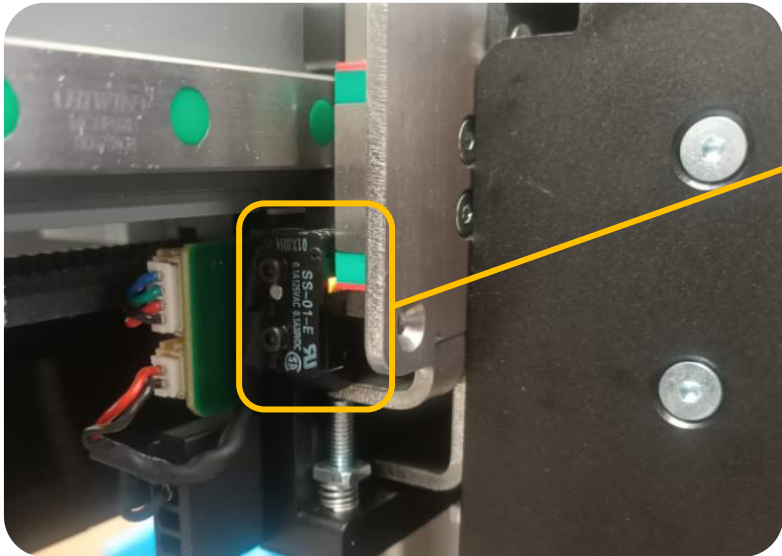
Sensor is **NORMALLY CLOSED** so the sensor is **not** triggered here!

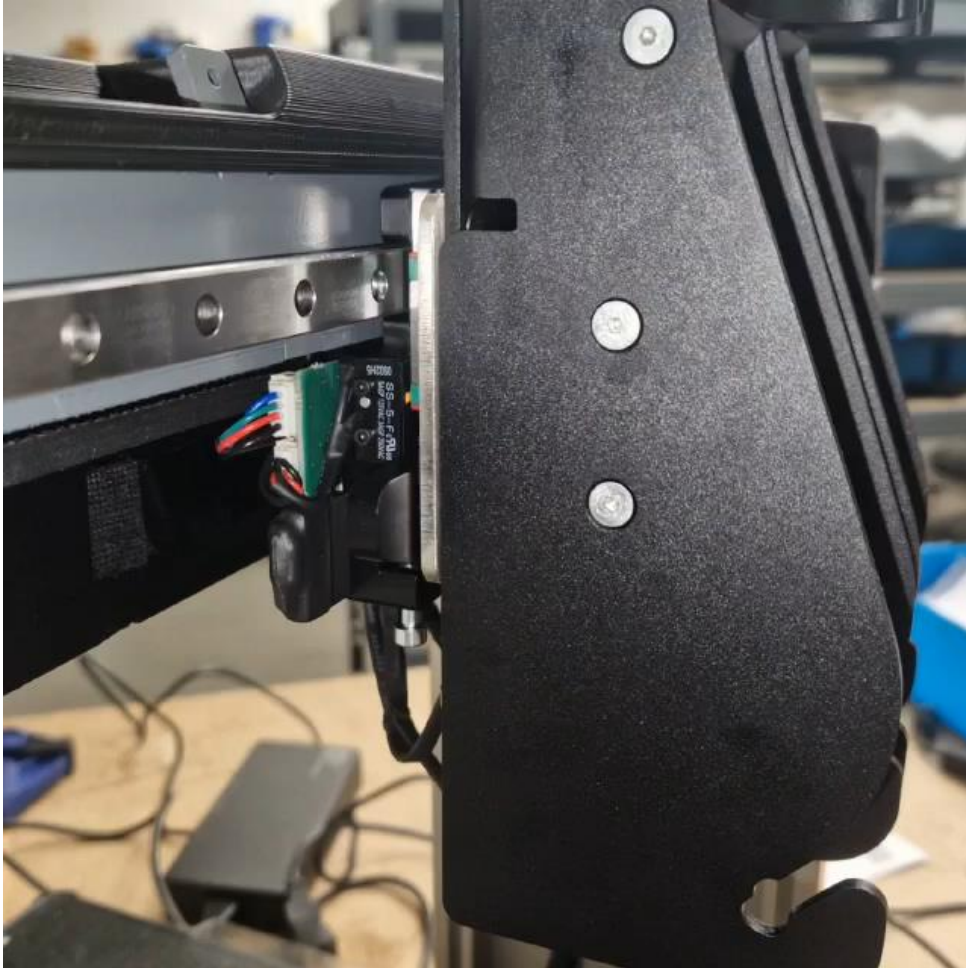
## Too little compensation

Too little compensation in the extruder

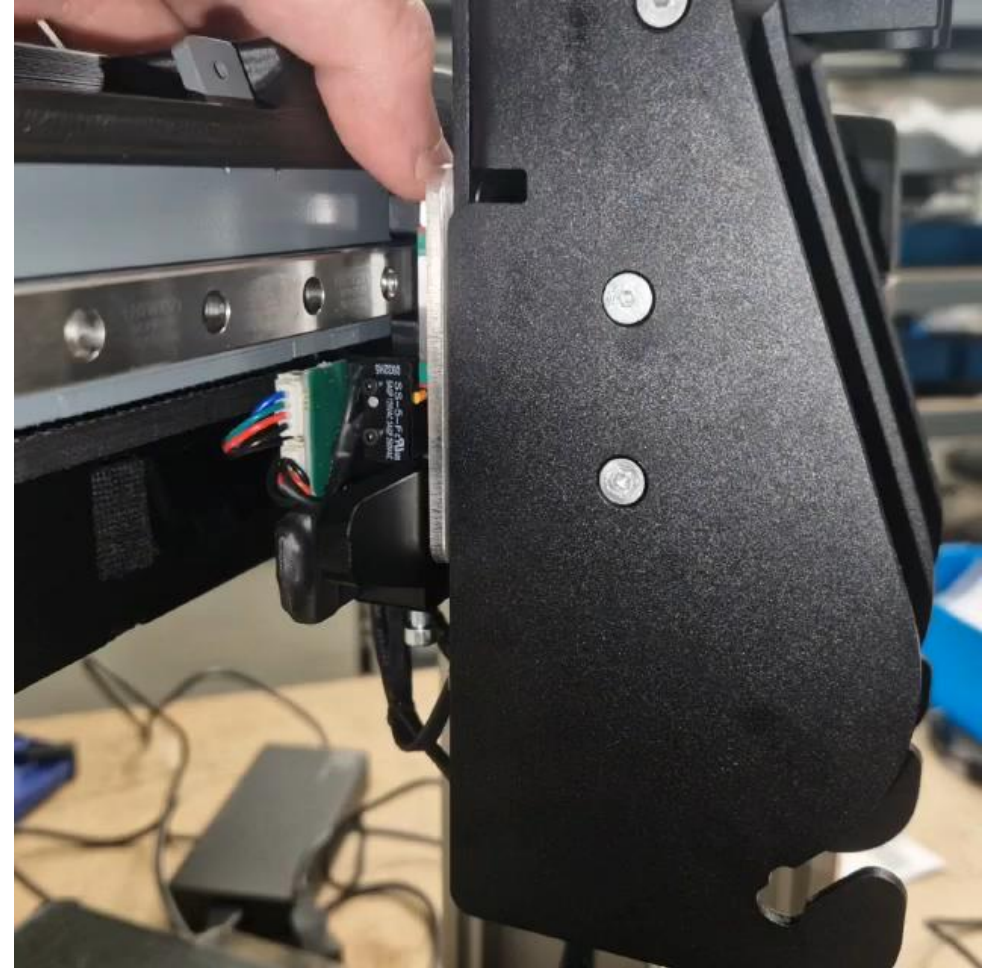
And thus too little compensation in the camshaft (CAM)

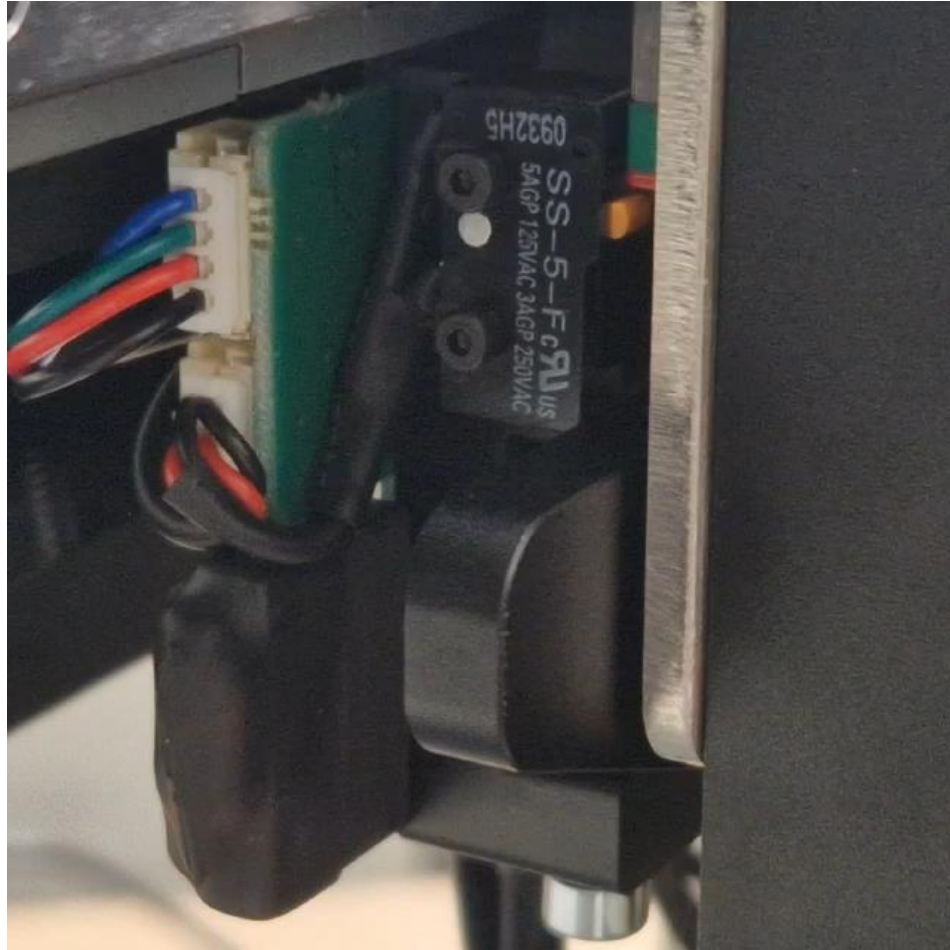
## Too much compensation

The compensation bolt compensates the weight so much that the sensor is not able to “untrigger”. This is the root cause of the bed levelling issues. If the sensor is less compensated it will be untriggered again and the bed levelling should work again.

CLOCKWISE: Less compensation  
ANTI CLOCKWISE: More compensation
